**INSULAR ABC 'S INITIATIVE
DEFERRED MAINTENANCE REDUCTION PROGRAM
St. Thomas / St. John School District
Monday, December 7, 2015**

REQUEST FOR PROPOSAL FOR STRUCTURAL DESIGN SERVICES

**DMRP-RFP – STTJ-003; STRUCURAL DESIGN FOR CHARLOTTE AMALIE HIGH
SCHOOLS**

CHARLOTTE AMALIE HIGH SCHOOL BUILDING 11

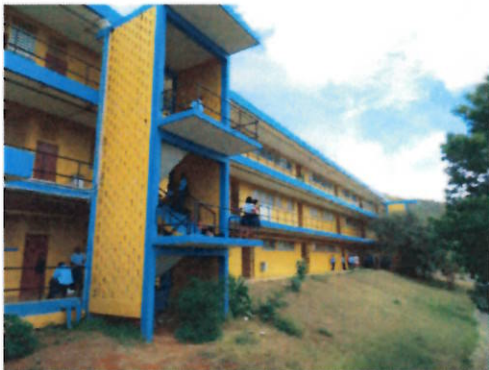
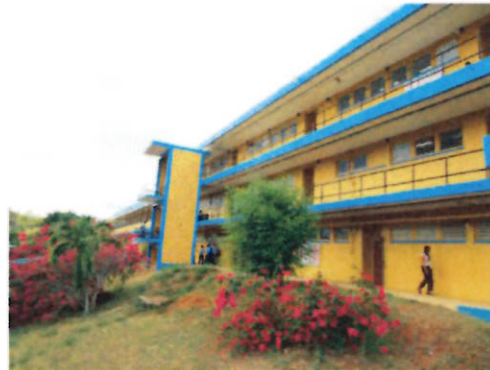
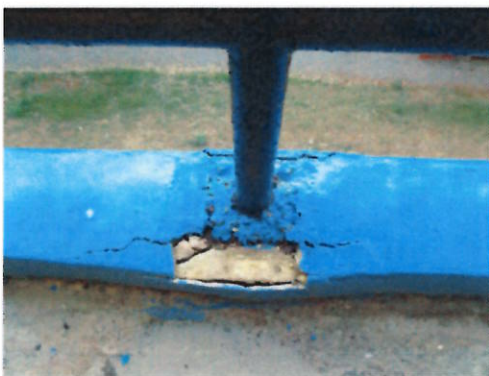
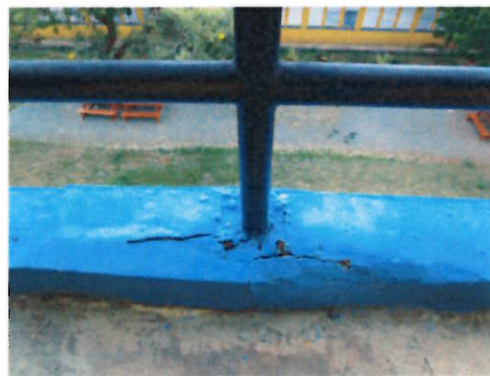
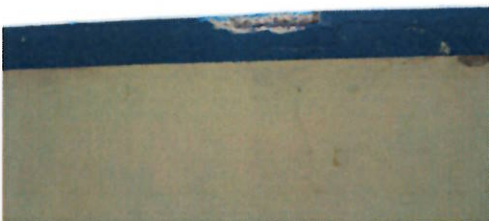
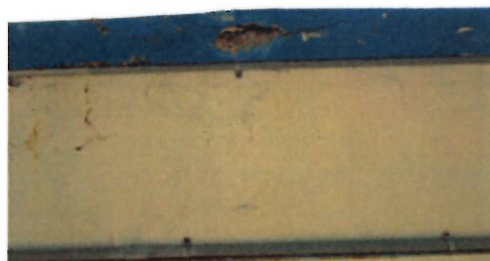
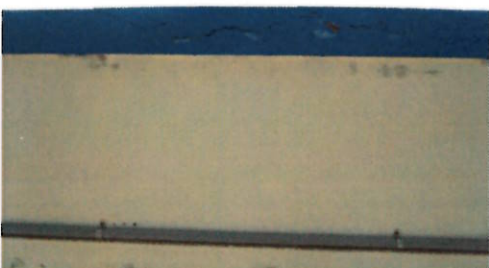
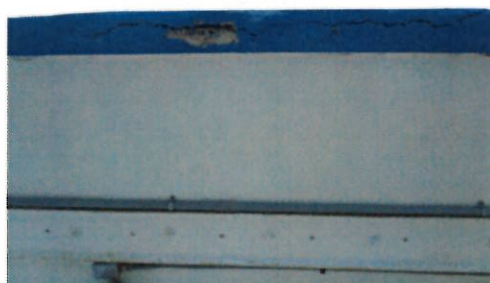
CHARLOTTE AMALIE HIGH SCHOOL BUILDING 11

It was observed that at the second and third floors, the base of the metal railing posts at the walkways has corroded and initiated spalling of the slab edge. The extent of the spalls (open and closed) varies depending on location along the building length. The spalls are likely caused because the base plate at the bottom of the railing post is embedded on a concrete curb at the edge of slab instead of being raised above the top of the curb. With the current post base detail, water ponds on top of the curb and accelerates corrosion of the post base plate. These spalls were identified as a life safety concern because they pose a falling hazard to the occupants of the building.

- 01 Conduct a survey of all cracks and spalls (open and closed) on the underside and edges of the floor and roof slabs along the south side of the building, particularly near railing post connections.

- 02 Fill all cracks and patch all spalls on the underside and edges of the concrete floor and roof slabs per approved concrete repair procedures. At spalls coinciding with locations of railing posts, clean the post base plate and its fasteners free of rust and replace curb reinforcing bars as required before installing patch material. Note that since the base plate of the railing post will remain prone to corrosion damage due to its elevation with respect to the top of the curb, this spall repair solution will only provide a short term solution.

- 03 As a long term consideration, replace the railing (or bottom portions of the posts and base plates) such that the post base plates are raised from the top of the curb via a grout bed.

- 04 It is recommended that the railing, particularly the posts and their base plates) be coated with a paint system appropriate for highly corrosive environments.

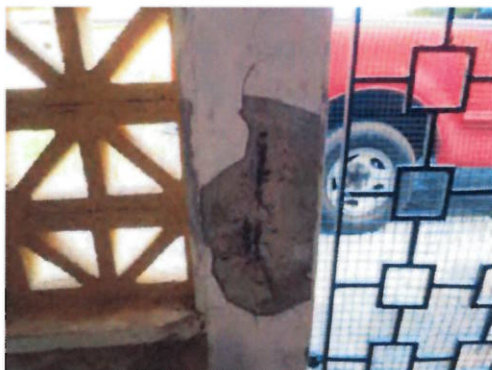
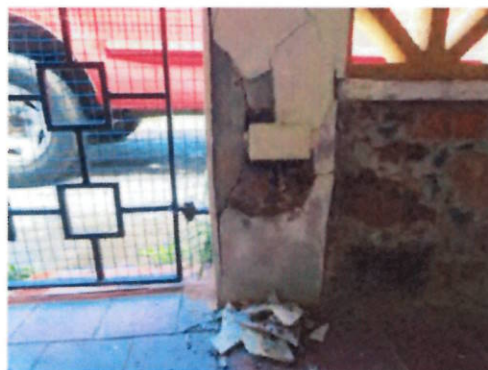
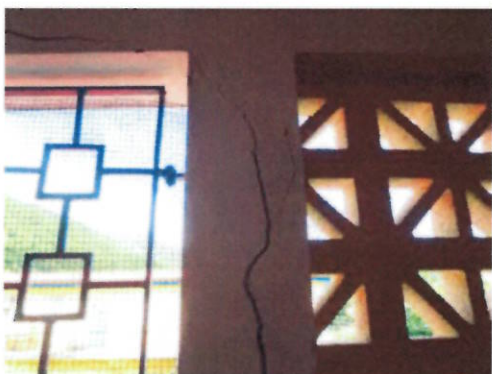
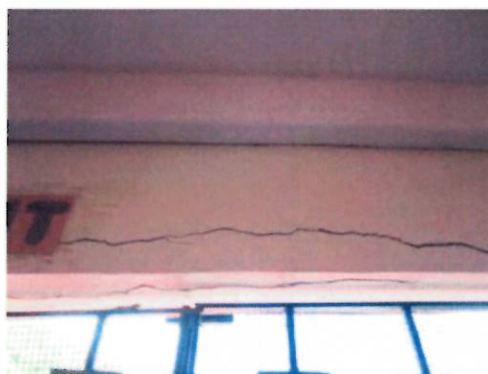
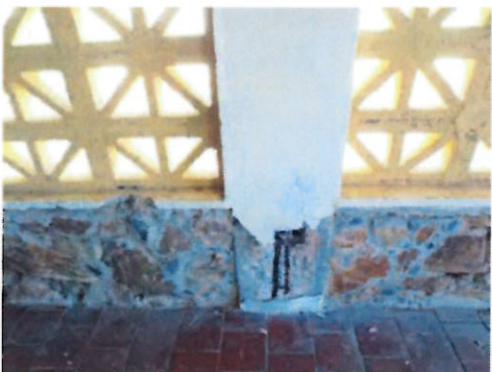
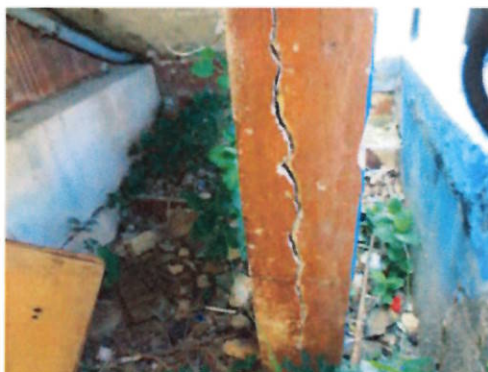
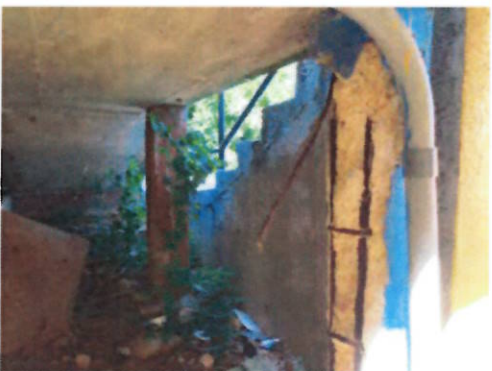
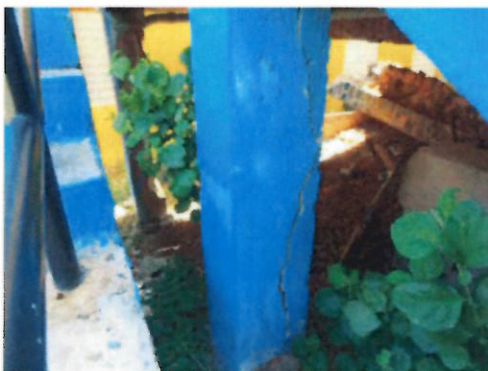
CHARLOTTE AMALIE HIGH SCHOOL BUILDING 20

Building 20 (Cottage) is a one-story building with a wood framed gable roof. Reinforced concrete beams and columns support the gravity loads from the wood-framed roof. Columns are typically 24 inches square. Foundations for the columns are below grade. Since the building is located on a sloped site, the columns on the south side of the building extend below the first floor of the building. Spalls with exposed reinforcing were observed at several of the concrete columns. On the North portion of the buildings (on-grade backyard porch), the spalls appear to be initiated by corrosion of electrical metal boxes (at receptacles) and metal conduits. In one case, the cracks and spalls in the columns extend to a header beam over a door opening. No exposed reinforcing was observed in this area of the building. On the south portion of the building (suspended front walkway), three columns were observed to be severely damaged. Here, concrete has spalled leaving reinforcing exposed. At one of the three columns (corner column), the cross section of the column has been reduced to less than 50% of its original size. In the front portion of the building, damage to the columns appears to be the result of insufficient clear cover to the reinforcing.

- 01 At the north portion of the building (on-grade backyard patio), chip and remove metal electrical boxes and conduit at damaged concrete columns. Install new PVC receptacles and conduit as required.

- 02 At the north portion of the building (on-grade backyard patio), fill all concrete cracks and patch all concrete spalls in columns and beams per approved concrete repair procedures. Fill all cavities resulting from the removal of electrical boxes and conduit per approved concrete repair procedures.

- 03 At the south portion of the building (suspended front walkway), shore walkway concrete beams as required at locations where the concrete columns have experienced a loss in cross section due to severe spalling.

- 04 At the south portion of the building (suspended front walkway), replace all concrete columns where loss of cross section has occurred: Demolish existing column from top of foundation to underside of concrete beam. Install vertical reinforcing dowels at top of foundation and at bottom of concrete beam. Use adhesive rated for exterior exposure to install reinforcing dowels. Install new column longitudinal and transverse reinforcing bars (longitudinal reinforcing bars to lap with vertical reinforcing dowels). Provide adequate clear cover to all reinforcing dowels and bars. Form and cast new concrete column.

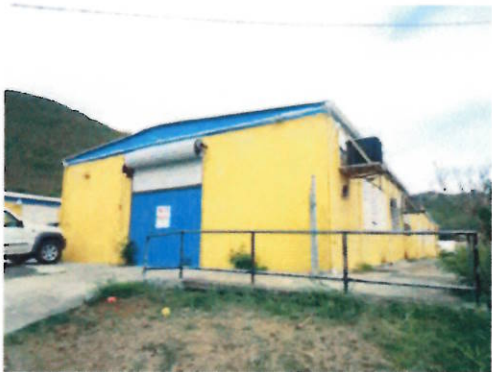
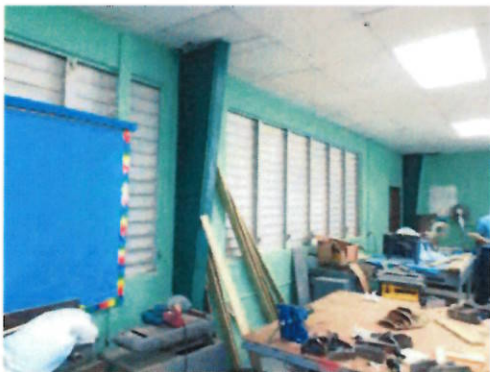
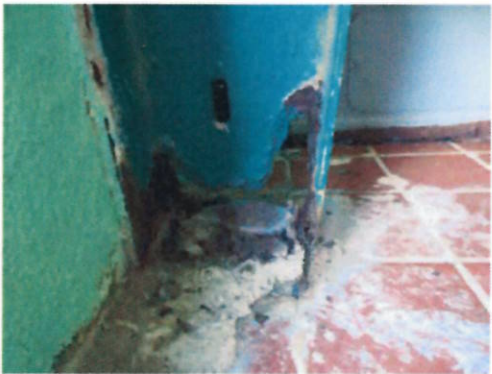
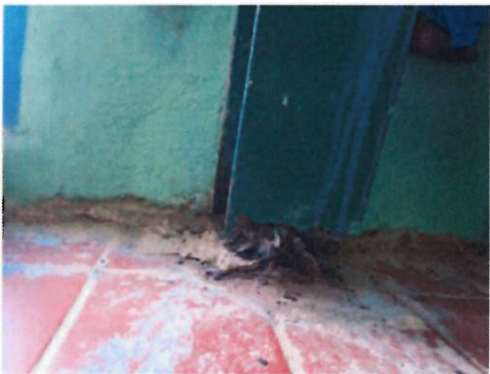
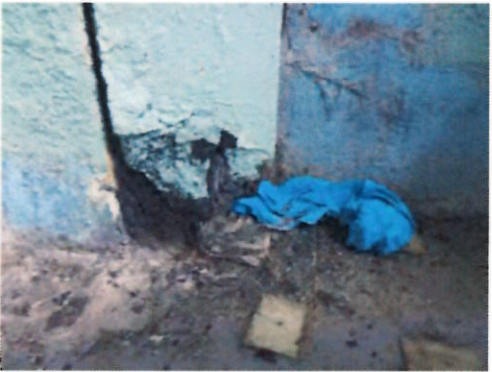
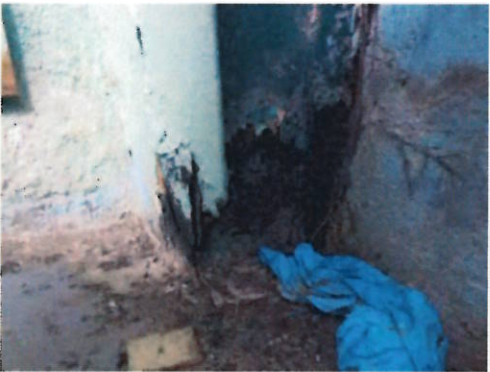
CHARLOTTE AMALIE HIGH SCHOOL BUILDING 30

Building 30 (Electrical and Carpentry Shop) is a one-story building with structural steel framing. The framing consists of structural steel rigid frames in the transverse direction of the building. Built-up sections with varying depth are used for the columns and beams in the frames. The frames span the width of the building and support a gable roof framed with cold-formed steel purlins and metal decking. At the base, the columns are connected to the top of the concrete slab-on-grade suggesting an integrated slab-on-grade foundation. Moderate to severe corrosion was observed at the bottom of several of the steel columns that make up the frames. In some cases, more than 50% of the cross section of the column was observed to be lost. The column base plates are severely corroded as well (two base plates have completely corroded away leaving the column practically bearing on top of the slab-on-grade/foundation). Corrosion at the bottom of the columns has occurred because of extensive leaks in the building's envelope (utility penetrations in the perimeter CMU walls and perforations in the roof decking). Because the top of the column base plates are flush with the top of the interior slab-on-grade, water infiltrating through the breaches in the building's envelope pond at the base of the columns. Therefore, the bottom portions of the columns and the column base plates are regularly exposed to rainwater and moisture. Note that this building is naturally ventilated and that there is no cladding/ceiling protecting the steel frames. Therefore, the steel frames are considered exterior and exposed.

- 01 Perform a survey and assess the condition of all steel columns in the building.
- 02 Provide shoring as required at the roof beams at locations where corrosion has resulted in loss of cross section at the bottom of the steel columns.

- 03 Repair all corroded steel columns and column base plates where loss of cross section has occurred: The suggested repair method is to cut-off the corroded portion at the base of the column and replace it with a new steel splice section of equal size and thickness as the existing column. As a preventive measure to minimize future corrosion, it is recommended that the column base plate be raised above the top of the slab-on-grade. This could be achieved by placing a 3-inch thick non-shrink grout bed between the top of the slab-on-grade/ foundation and the bottom of the base plate. The new column splice section would have a base plate shop welded to its bottom and would be fastened to the top of the slab-on-grade/foundation via post-installed anchor rods. The top of the new column splice section would be field welded to the bottom of the existing column.

- 04 Clean and prepare the steel column and its base plate (exterior and exposed) as recommended by the Society for Protective Coatings (SSPC). Apply a three-coat system consisting of one primer coat and one mid-coat of epoxy-polyamide and one finish coat of aliphatic polyurethane.

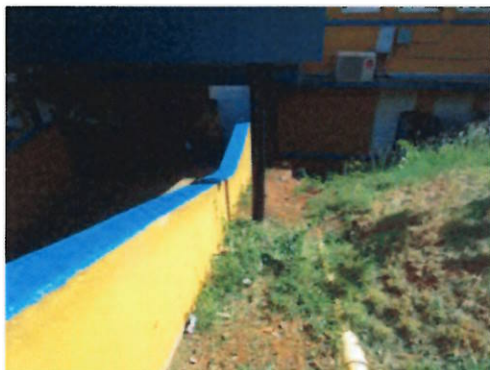
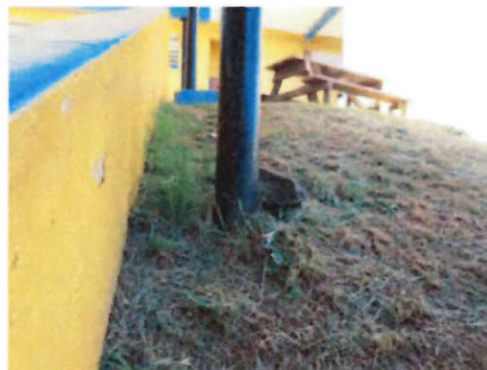
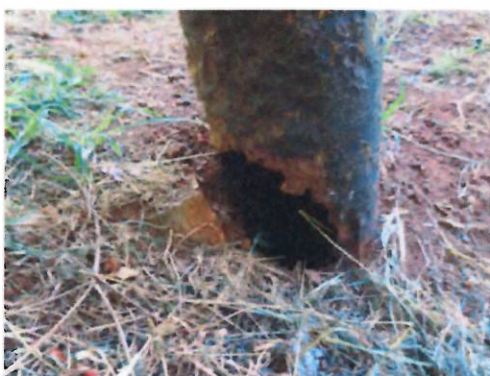
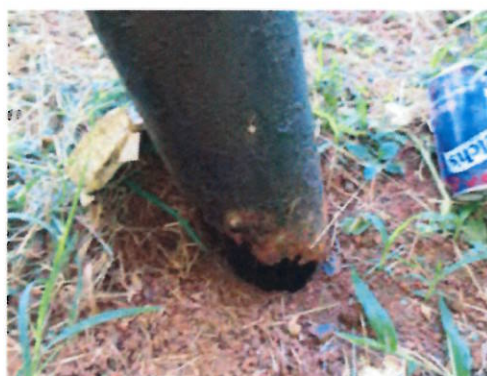
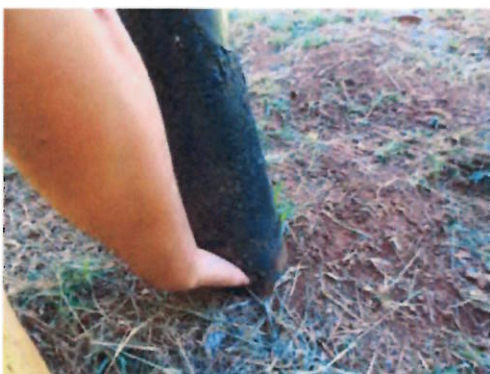
CHARLOTTE AMALIE HIGH SCHOOL WALKWAYS

The walkways connecting the major buildings on the campus consist of structural steel pipe columns supporting a two-way concrete slab. Typical column spacing is approximately 8'-0" on center. Foundations for the columns as well as the column base plates are below grade. Therefore, connection details at the base of the columns could not be observed. Moderate to severe corrosion exists at the bottom of several of the columns, and in some cases, more than 50% of the cross section of the columns has been lost. It is reasonable to assume that the column base plates exhibit similar or more extensive damage than the visible portions of the columns right above grade. Corrosion at the bottom of the columns occurs because the column base plates are embedded below grade. Hence, the bottom portions of the columns are continuously in direct contact with earth, rainwater, and moisture.

- 01 Provide shoring as required at the walkway roof slab at locations where corrosion has resulted in loss of cross section at the bottom of the steel columns.

- 02 Remove finish grade to expose the column base plates at all columns and assess their condition.
- 03 Repair all corroded steel columns and column base plates where loss of cross section has occurred: The suggested repair method is to cut-off the corroded portion at the base of the column and replace it with a new steel pipe splice section of equal size and thickness as the existing column. To prevent the corrosion from reoccurring, it is recommended that the column base plate be raised such that it is a minimum of four inches above grade. To raise the column base plate, it is suggested that a new concrete pedestal be constructed atop the existing foundation. The new pedestal would be connected to the existing foundation via post-installed reinforcing dowels. At the top of the pedestal, the new pipe splice section (with new base plate at the bottom) would be fastened through cast-in anchor rods. Lastly, the top of the new pipe splice section would be field welded all around to the bottom of the existing column.

- 04 Clean and prepare the steel column and its base and top plates (exterior and exposed) as recommended by the Society for Protective Coatings (SSPC). Apply a three-coat system consisting of one primer coat and one mid-coat of epoxy-polyamide and one finish coat of aliphatic polyurethane.

- 05 It is recommended that the base plates be raised above grade at all columns per item 03 above, including those where corrosion has not yet resulted in loss of cross section at the column base plate and/or at the base of the column.
