**INSULAR ABC 'S INITIATIVE  
DEFERRED MAINTENANCE REDUCTION PROGRAM  
St. Thomas / St. John School District  
Monday, December 7, 2015**

**REQUEST FOR PROPOSAL FOR STRUCTURAL ASSESSMENT & DESIGN  
SERVICES**

**DMRP-RFP – STTJ-001; STRUCURAL DESIGN FOR ULLA MULLER ELEMENTARY  
SCHOOL**

## ULLA MULLER ELEMENTARY SCHOOL BUILDINGS 3 AND 4

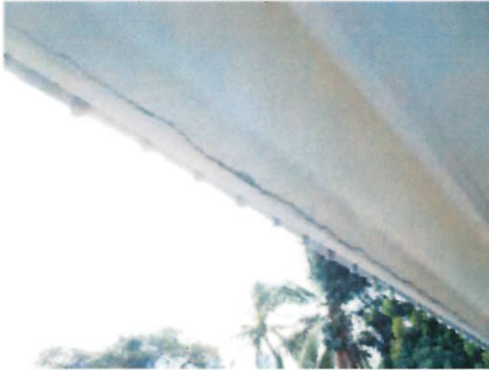
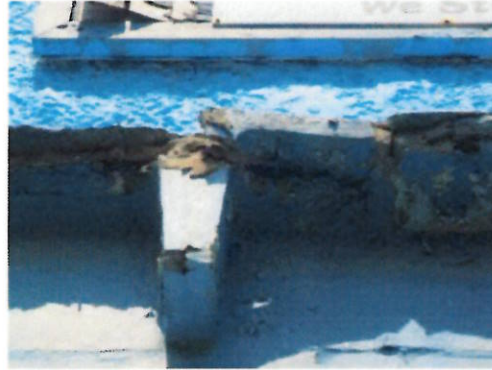
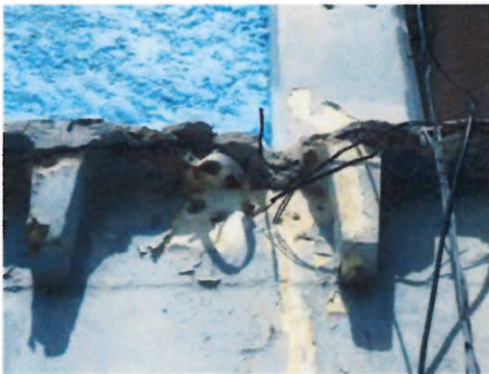
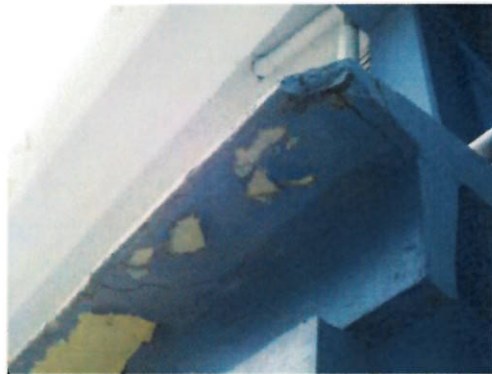
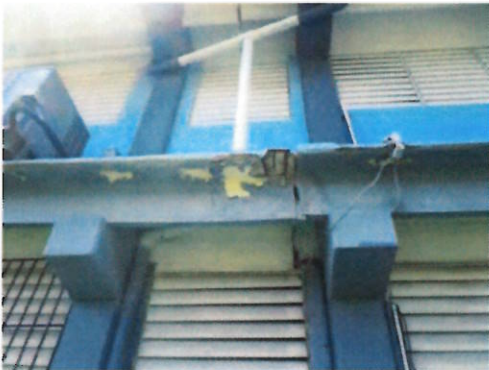
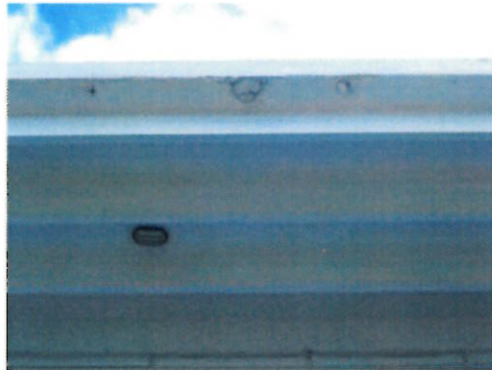
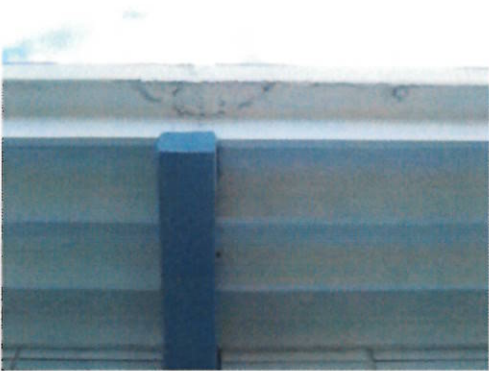
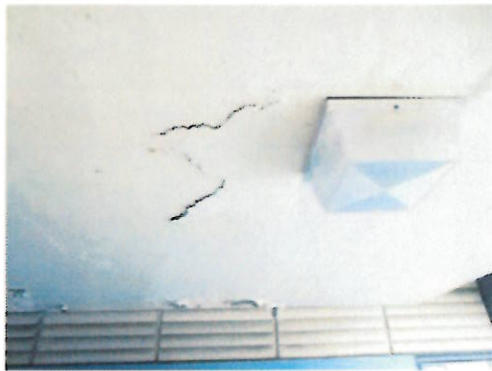
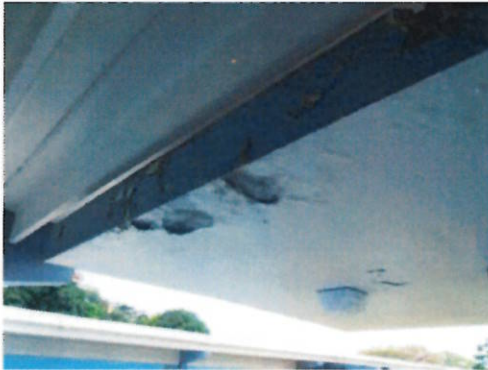
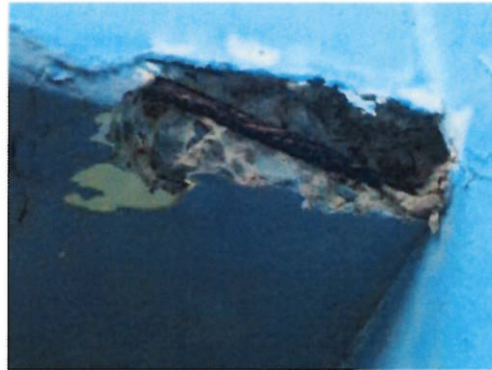
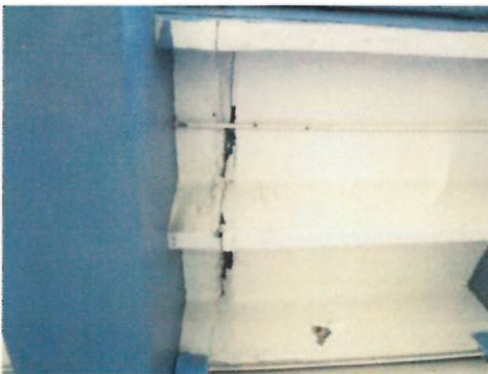
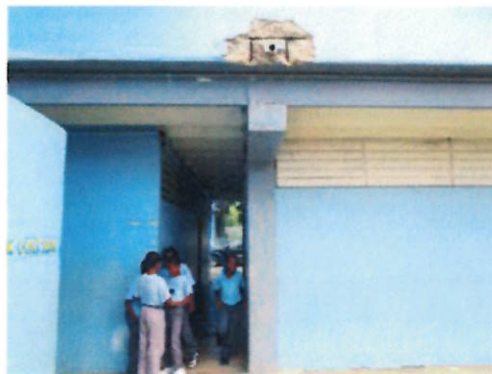
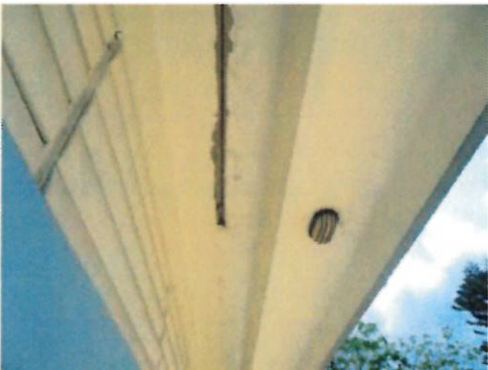
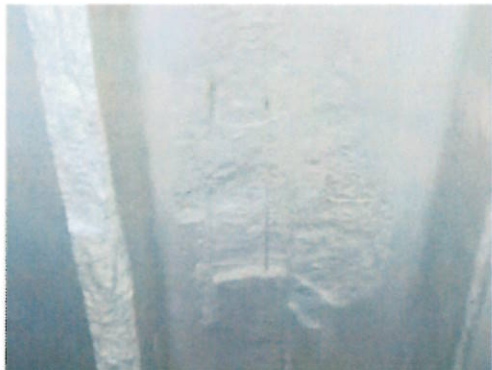
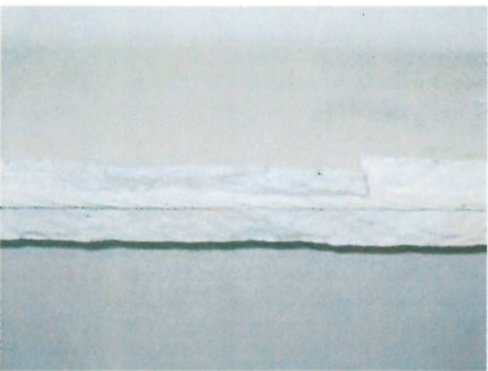
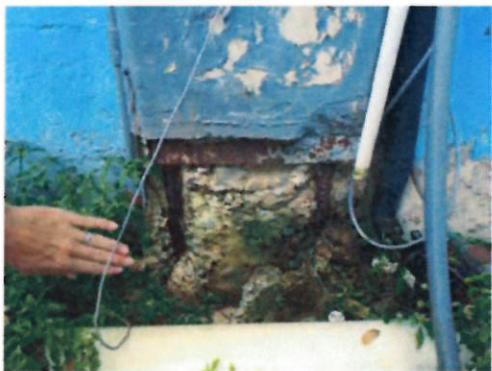
**ULLA MULLER ELEMENTARY SCHOOL BUILDINGS 3 AND 4**

Moderate to severe spalls were observed at the precast tees at the second floor and at the roof. The spalls are for the most part concentrated on areas where the tees are exposed to weather: at the walkways and at a short overhang around the perimeter of the buildings. In some cases, exposed reinforcing was observed. Closed or partially closed spalls on the underside and on the sides of concrete members are considered a life safety concern for they can detach unexpectedly and fall on building occupants. At the underside of the tees, it was also observed that at the joint between adjacent precast tees, the tooled joint filler has cracked and in some cases fallen. This loose material is also considered a falling hazard and should hence be treated as a life safety issue.

At the precast tees, exposed pre-stressing tendons were observed at two locations on Building 3. It appeared that the concrete had spalled from the underside of the tee's web leaving approximately 4-foot long portions of the tendons exposed. It was not possible to verify the condition of the exposed tendon for the areas around the spall and the tendon itself have been painted white.

Spalls (open and closed) were also observed on the concrete wall that serves as a railing to the second floor walkway that provides access to the classrooms. It was reported by a teacher that a large spall had recently detached from this wall and fallen down to the grounds below.

Spalls were also observed at the bottom of exterior concrete columns near grade. The spalls were moderate, with exposed reinforcing in some cases. Damage to the columns was typically observed to be a result of improper drainage of air conditioning units (water from the units drains directly on to the base of the column).

- 01 Conduct a structural survey of all exposed precast and cast-in-place concrete elements. The survey shall document the type, location, size, and extent of all cracks and spalls (open and closed). The survey shall also document the location, extent, and condition of exposed pre-stressing tendons in precast pre-stressed concrete tees.
- 02 Fill all cracks and patch all spalls in cast-in-place concrete columns, walls, and beams per approved concrete repair procedures.
- 03 Fill all cracks and patch all spalls in precast pre-stressed concrete tees per approved concrete repair procedures.

- 04 Thoroughly clean and remove all rust from exposed pre-stressing tendons in precast pre-stressed tees. Patch the areas around the exposed tendons per approved concrete repair procedures. If it is determined that loss of pre-stressing force in the tendon has occurred, additional reinforcing may be required. A suggested form of additional reinforcing is in the form of glass or carbon fiber sheets bonded to the underside of the web of the affected tee.
- 05 Remove all loose and cracked joint fill material from the underside of joints between precast pre-stressed tees. Install new joint filler at all joints.
- 06 A licensed structural engineer shall perform all surveys, design all concrete repair details, design all pre-stressing tendon repair details, and prepare all required specifications.

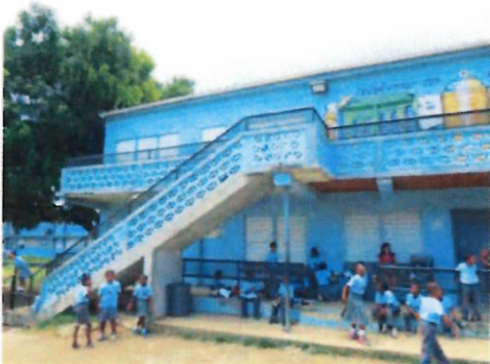
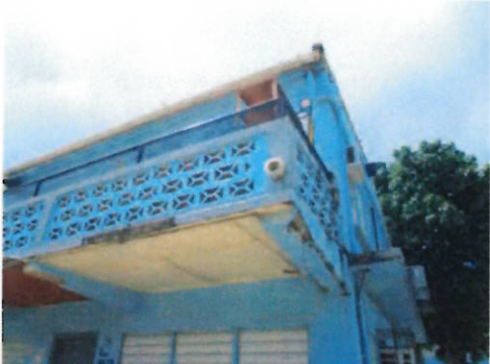
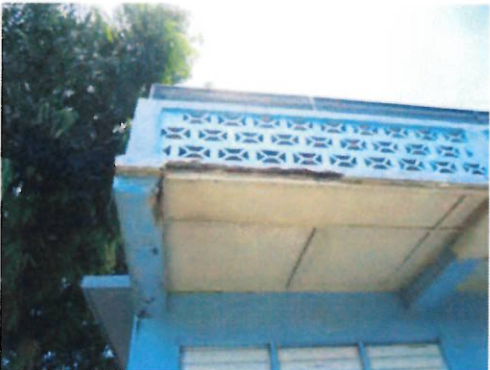
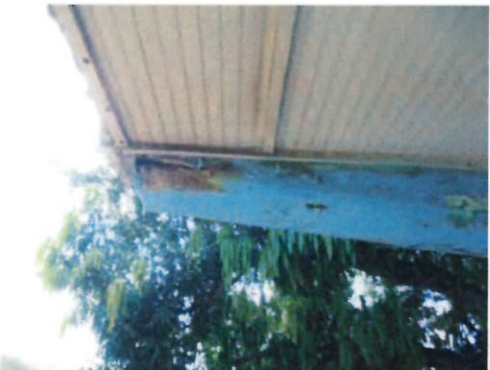
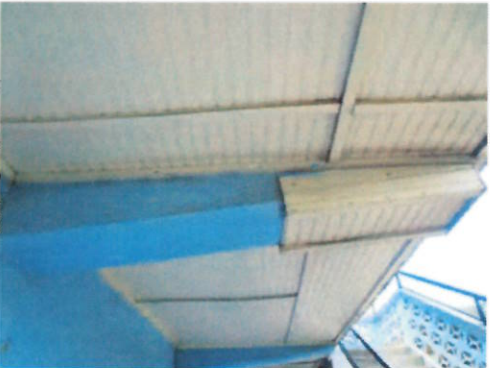
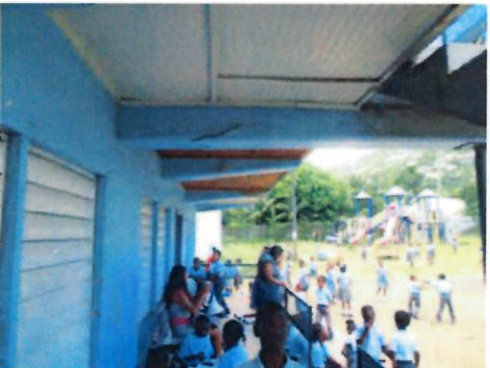
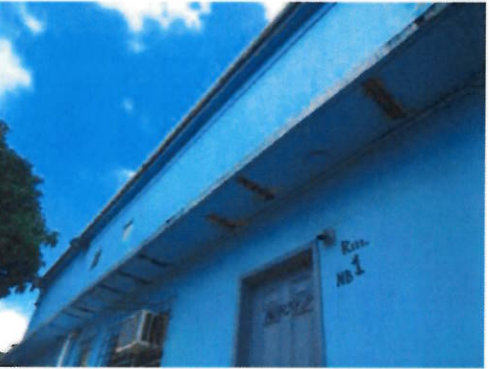
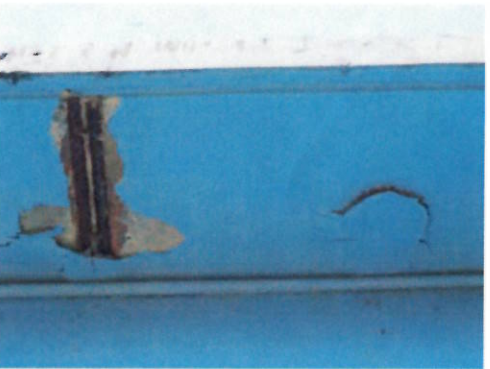
**ULLA MULLER ELEMENTARY SCHOOL BUILDING 5**

On the east side of the building, the second floor framing cantilevers beyond the perimeter of the building to create a walkway for access to the second floor classrooms. Cantilever concrete beams of varying depth typically provide support for this second floor walkway. These cantilever beams were observed to be in poor condition due to severe and widespread spalls with exposed reinforcing. In some cases, the spalls are on the underside of the beam creating a life safety concern (falling hazard).

At one location, a simple-span concrete beam instead of a cantilever beam supports the second floor walkway. This simple-span beam spans between the perimeter of the building and a concrete wall supporting an exterior concrete stair. A large diagonal crack extending through most of the cross section was observed near the middle third of the span of this concrete beam. The crack appears to be a shear crack and given the brittle and unexpected nature of a shear failure, the damage on this beam is considered a life safety issue.

On the north, south, and west sides of the building, the second floor concrete slab cantilevers beyond the perimeter of the building to create a short awning. At the underside of this overhang, there are open and closed spalls that coincide with the spacing of what appears to be either reinforcing bars or some type of metal fitting. It has been reported that a large piece of concrete recently detached from the underside of this overhang and fell on top of the entrance to the nurse's room. It was also observed that the underside of the second floor slab at the walkway has been covered up with plywood. It is unknown whether the plywood was added as a protective measure against falling debris from spalled concrete.

- 01 Provide shoring as required at the second floor walkway slab and beams.
- 02 Remove plywood sheathing from the underside of second floor walkway slab. Patch all concrete spalls, if any, per approved concrete repair procedures.
- 03 Fill all cracks and patch all spalls at the cantilever portions of the second floor slab (awning on north, south, and west sides of the building) per approved concrete repair procedures.
- 04 Fill all cracks and patch all spalls at the cantilever concrete beams supporting the second floor walkway slab per approved concrete repair procedures.
- 05 Repair, reinforce, and/or replace the second floor walkway concrete beam spanning between building wall and stair wall.
